Examples of Non-Complaint Power Leads found during the first round of scheduled testing:

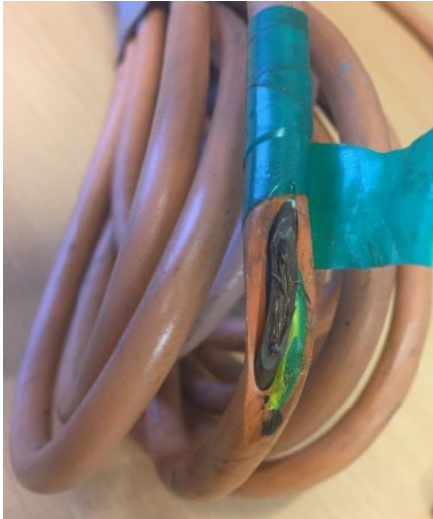
This lead which had been sliced exposing the wire sheathing & wires. It had been covered in green electrical tape and was encased in conduit and when we pulled the lead out water ran out of the conduit!

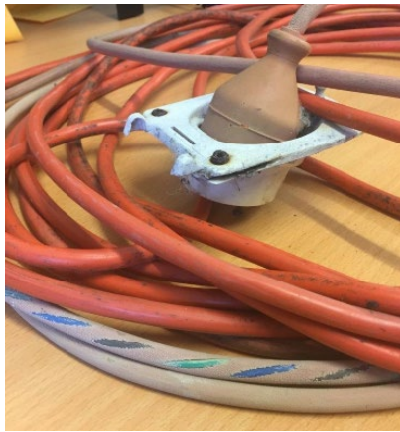
The insulation (orange) was so weathered and degraded that you can see the wire sheathing. The plug socket could not be disconnected from the van inlet as they had fused together.

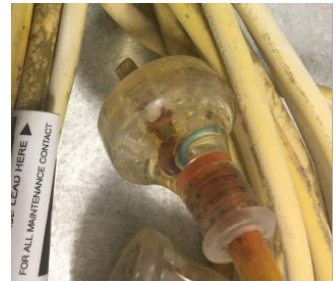
This plug's pin had been damaged most likely due to constantly drawing a high volume of power.

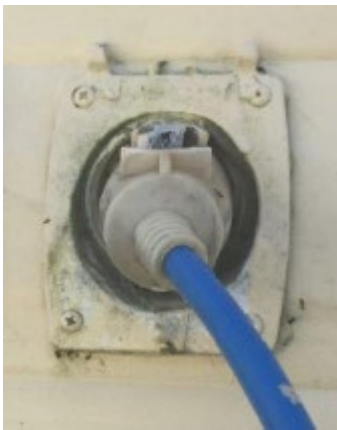
This inlet is non-compliant as it has no weather flap. Broken weather flaps are also non-compliant. Removable plug ends MUST be clear, not opaque as this one is.

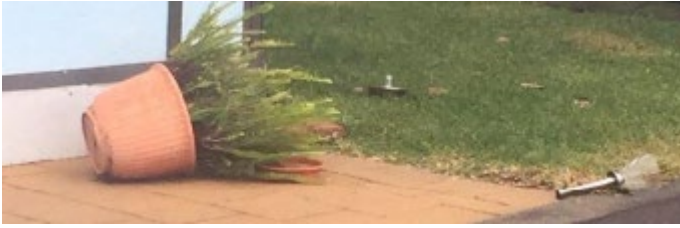
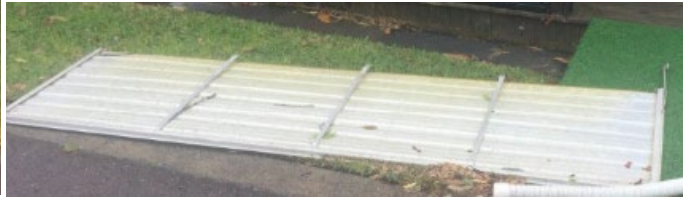
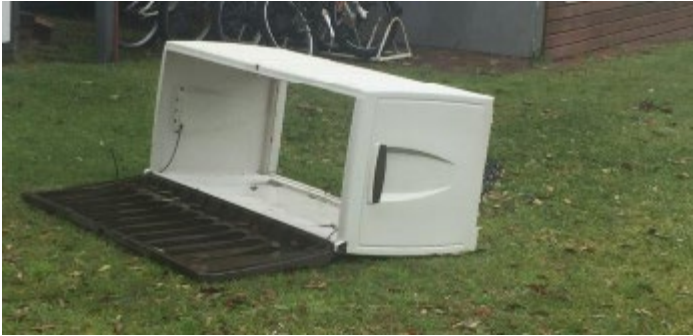
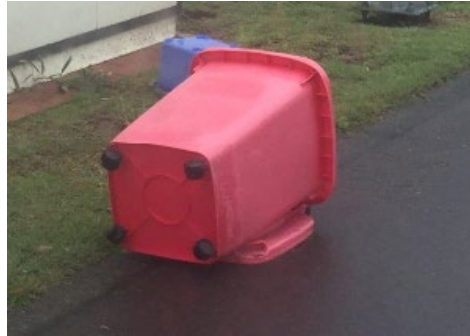
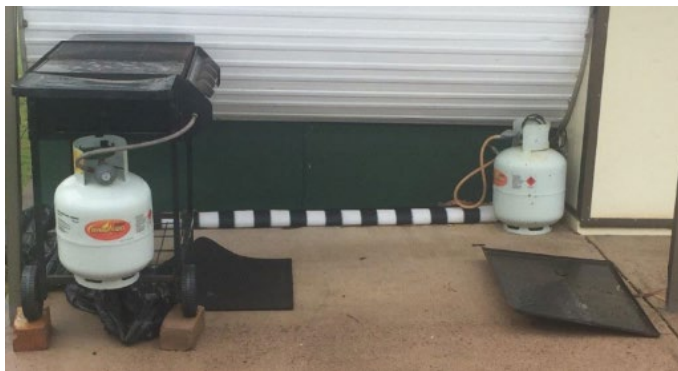
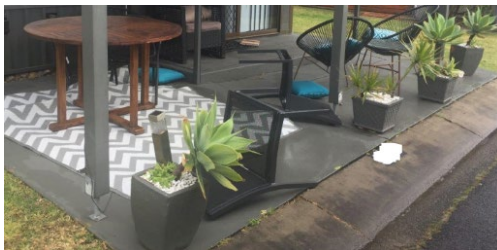
Site Safety

Here are just a few examples of what we found strewn around the park after the storm we had this week.
